Repair techniques in Underwater Pipelines for Drinking Water

Tri Suyono^{1*}, Agustinus Purna Irawan², Wati Asriningsih Pranoto²

Abstract. Changes in sea weather, especially the strait facing the open sea, will greatly affect inter-island underwater drinking water pipelines, which can cause damage to pipelines made from High Density Polyethylene (HDPE). Damage that often occurs is broken or folded, so repairs will be difficult given the position of the damaged pipe is at the bottom of the sea, so that special needs to be repaired. Repairing underwater drinking water pipes is done by lifting pipes from the seabed with floats made of plastic drums. After the pipe is lifted from the seabed to the surface of the sea water the pipe will be connected in accordance with the connection procedure and subsequently drowned again by installing ballast. The length of the pipe raised to the surface of the sea is taken at least 1.5 depth of the sea on the damaged pipe making it easier to repair or reconnect. To lift one side of an underwater drinking water pipe type HDPE PN.10 bar with a diameter of 110 mm that breaks at a depth of 42 m requires a float of 13 units to be installed on a ballast

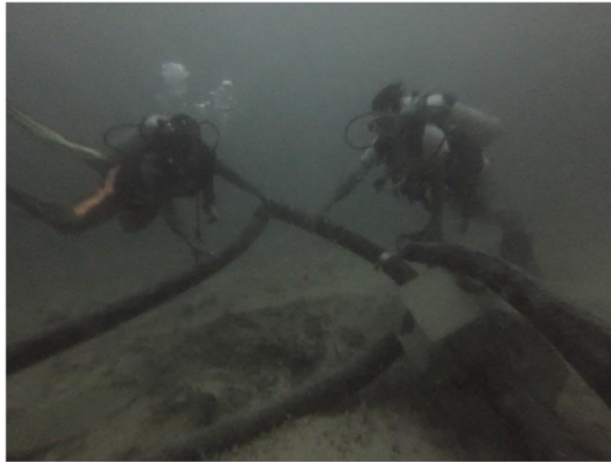
Damage to drinking water pipes installed at the bottom of the sea with HDPE pipe material is a change in shape (buckling), folded and also broken [4-5]. Repairing pipes at the bottom of the sea will be difficult if it is not raised to the surface, because work at sea requires specialized equipment with professional staff. In addition to the safety risks of workers the risk of failure to work on the pipeline at sea is also quite high, especially if the conditions at sea level are quite heavy [6]. Things that need to be considered in lifting the pipe is the calculation of the weight of the pipe and the ballast concrete so that it can calculate the dimensions and the number of floats needed. Calculation of weight to be lifted and float can be calculated by equations 1, 2 and 3.

Figure 1. Examples of underwater pipelines damage

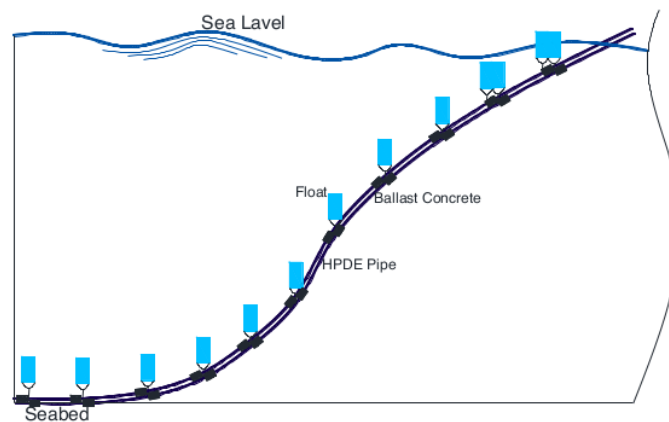
Figure 2. The layout of the float drum

The float used is a platinum drum with an empty volume of 205 liters and has a buoyancy of 165 kg, so that one ballast point can be lifted with one drained drum [9-10]. Floating a 1.5 pipe from the length of the pipe then requires a minimum of 11 units of float drum. To simplify the process of connecting at two points the front end of the pipe to be joined added floats [11-13], so that in this case as many as 13 units of floating drums are used, the layout of which can be seen in Figure 2. Floating pipes and pipe joints can be seen in Figures 3 and 4. The connection process is carried out in accordance with the standard for PN 10 bar HDPE pipes, with an estimated connection time of about 40 min per point.

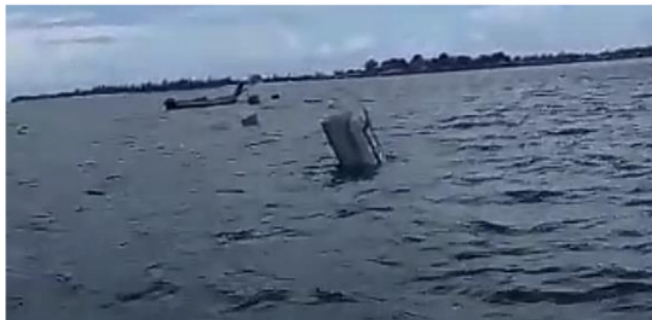
Figure 3. Floats that arise on the surface

After all the drums have been filled properly, the diver must remove the water from the drum by spraying air from the compressor tube into the hollow drum section, so that the water from the drum exits and the air left in the drum will tighten the pipe and ballast upwards [8]. The process of erasing water from the drum is carried out from the endpoint to be repaired and continuously sequentially to the very back, so that the end of the pipe to be repaired or connected emerges to the surface of the sea water and subsequently repair or connection. After the repair process, the pipe must be submerged again. The adding ballast concrete to the part needed and releasing the drum in sequence from the deepest part.

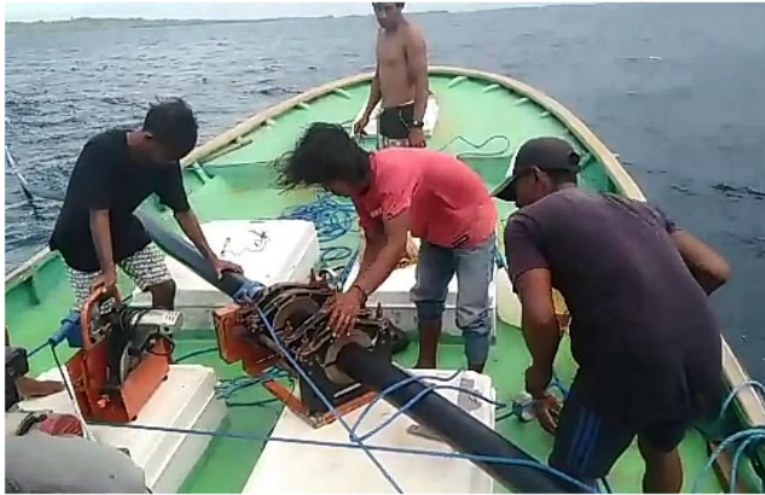
Figure 4. Pipe connection that has been floated
